REPORT: FE-19-97

RAILROAD: Norfolk Southern Railway Company (NS)

LOCATION: Rowesville, South Carolina

DATE TIME: June 24, 1997, 8:58 p.m., EST

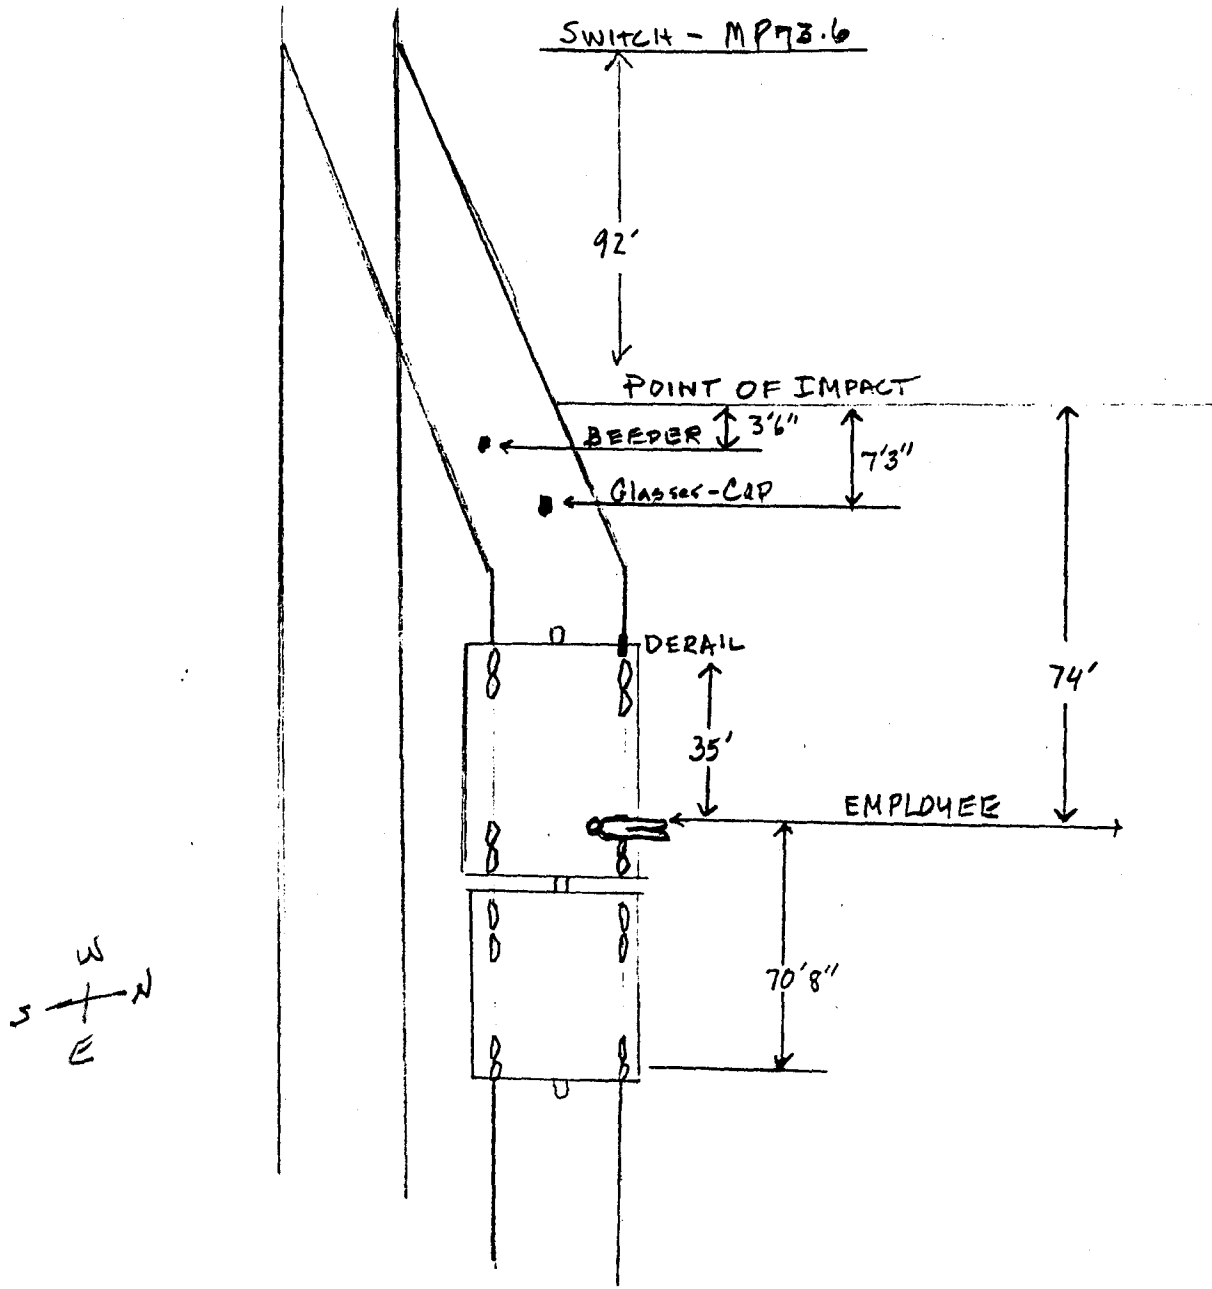
ACCIDENT SCENE

The post-accident investigation disclosed that the Conductor had failed to line the switch for the mainline after applying the EOT to the rear of Rail Car SOU 88568. After pulling west from the siding with five cars and applying the EOT, the Conductor instructed the Engineer to shove east, informing the Engineer that the track was clear for 30 car lengths, but only to shove back five car lengths. The Conductor’s intent was to cut two cars off of the mainline and return to the siding with the three remaining cars.

Evidence indicates that as the shoving move began, the Conductor turned away from the rolling equipment and walked toward the west in the foul of the siding track. At the same time, utilizing his radio, he was issuing movement instructions to the Engineer. The Conductor’s failure to properly line the main track switch resulted in the cars re-entering the siding and

striking him in the back. As result of being struck by the rolling equipment, the Conductor was knocked to the ground and run over by his own train.
